Revelations of German Pilot: Shocking Analysis of the « Shooting Down » of Malaysian MH17. « Aircraft Was Not Hit by a Missile »

Par [Peter Haisenko](#)

Mondialisation.ca, 26 avril 2016

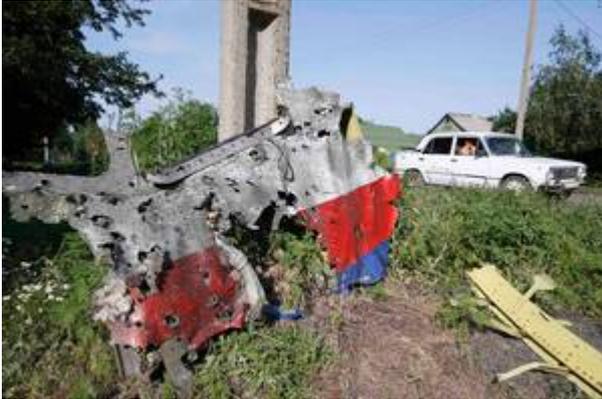
Entry and exit impact holes of projectiles in the cockpit area

I recommend to click on the little picture to the left. You can download this photo as a PDF in good resolution. This is necessary, because that will allow you understand what I am describing here. The facts speak clear and loud and are beyond the realm of speculation: The cockpit shows traces of shelling! You can see the entry and exit holes. The edge of a portion of the holes is bent inwards. These are the smaller holes, round and clean, showing the entry points most likely that of a 30 millimeter caliber projectile. The edge of the other, the larger and slightly frayed exit holes showing shreds of metal pointing produced by the same caliber projectiles. Moreover, it is evident that at these exit holes of the outer layer of the double aluminum reinforced structure are shredded or bent - outwardly! Furthermore, minor cuts can be seen, all bent outward, which indicate that shrapnel had forcefully exited through the outer skin from the inside of the cockpit. The open rivets are also bent outward.

In sifting through the available images one thing stands out: All wreckage of the sections behind the cockpit are largely intact, except for the fact that only fragments of the aircraft remained . Only the cockpit part shows these peculiar marks of destruction. This leaves the examiner with an important clue. This aircraft was not hit by a missile in the central portion. The destruction is limited to the cockpit area. Now you have to factor in that this part is constructed of specially reinforced material. This is on account of the nose of any aircraft having to withstand the impact of a large bird at high speeds. You can see in the photo, that in this area significantly stronger aluminum alloys were being installed than in the remainder of the outer skin of the fuselage. One remembers the crash of Pan Am over Lockerbie. It was a large segment of the cockpit that due to the special architecture survived the crash in one piece. In the case of flight MH 017 it becomes abundantly clear that there also an explosion took place inside the aircraft.

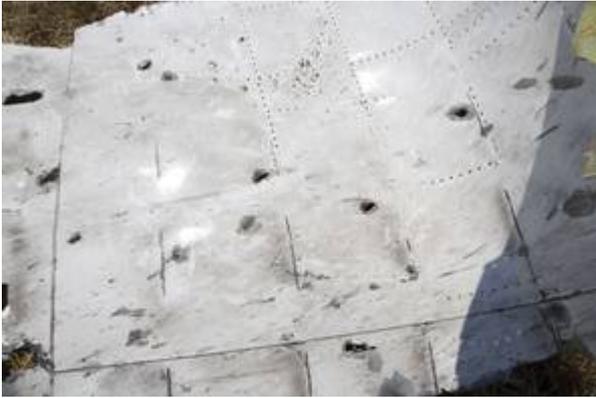
Tank destroying mix of ammunition

Bullet holes in the outer skin

Now just consider what happens when a series of anti-tank incendiary shells and splinter-explosive shells hit the cockpit. These are after all designed to destroy a modern tank. The anti-tank incendiary shells partially traversed the cockpit and exited on the other side in a slightly deformed shape. (Aviation forensic experts could possibly find them on the ground presumably controlled by the Kiev Ukrainian military; the translator). After all, their impact is designed to penetrate the solid armor of a tank. Also, the splinter-explosive shells will, due to their numerous impacts too cause massive explosions inside the cockpit, since they are designed to do this. Given the rapid firing sequence of the GSh-302 cannon, it will cause a rapid succession of explosions within the cockpit area in a very short time. Remember each of these is sufficient to destroy a tank.

So what could have happened? Russia recently published radar recordings, that confirm at least one Ukrainian SU 25 in close proximity to MH 017. This corresponds with the statement of the now missing Spanish controller 'Carlos' that has seen two Ukrainian fighter aircraft in the immediate vicinity of MH 017. If we now consider the armament of a typical SU 25 we learn this: It is equipped with a double-barreled 30-mm gun, type GSh-302 / AO-17A, equipped with: a 250 round magazine of anti-tank incendiary shells and splinter-explosive shells (dum-dum), arranged in alternating order. The cockpit of the MH 017 has evidently been fired at from both sides: the entry and exit holes are found on the same fragment of it's cockpit segment!

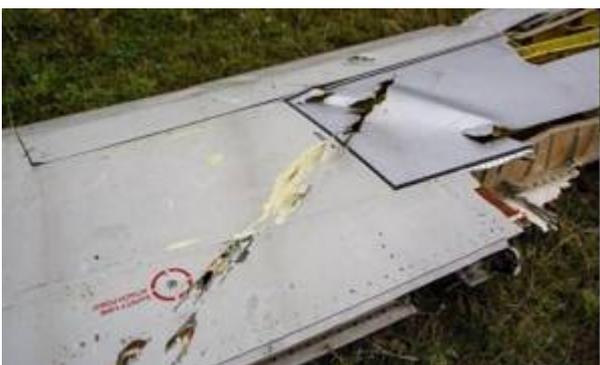
Graze on the wing

Because the interior of a commercial aircraft is a hermetically sealed pressurized chamber, the explosions will, in split second, increase the pressure inside the cabin to extreme levels or breaking point. An aircraft is not equipped for this, it will burst like a balloon. This explains a coherent scenario. The largely intact fragments of the rear sections broke in mid air at the weaker points of construction most likely under extreme internal air pressure. The images of the widely scattered field of debris and the brutally damaged segment of cockpit fit like hand in glove. Furthermore, a wing segment shows traces of a grazing shot, which in

direct extension leads to the cockpit. Interestingly, I found that both the high-resolution photo of the fragment of bullet riddled cockpit as well as the segment of grazed wing have in the meantime disappeared from Google Images. One can find virtually no more pictures of the wreckage, except the well known smoking ruins.
