Radiation Levels Are Soaring inside the Damaged Fukushima Nuclear Plant

Mondialisation.ca, 04 février 2017

[Gizmodo](#) 3 février 2017

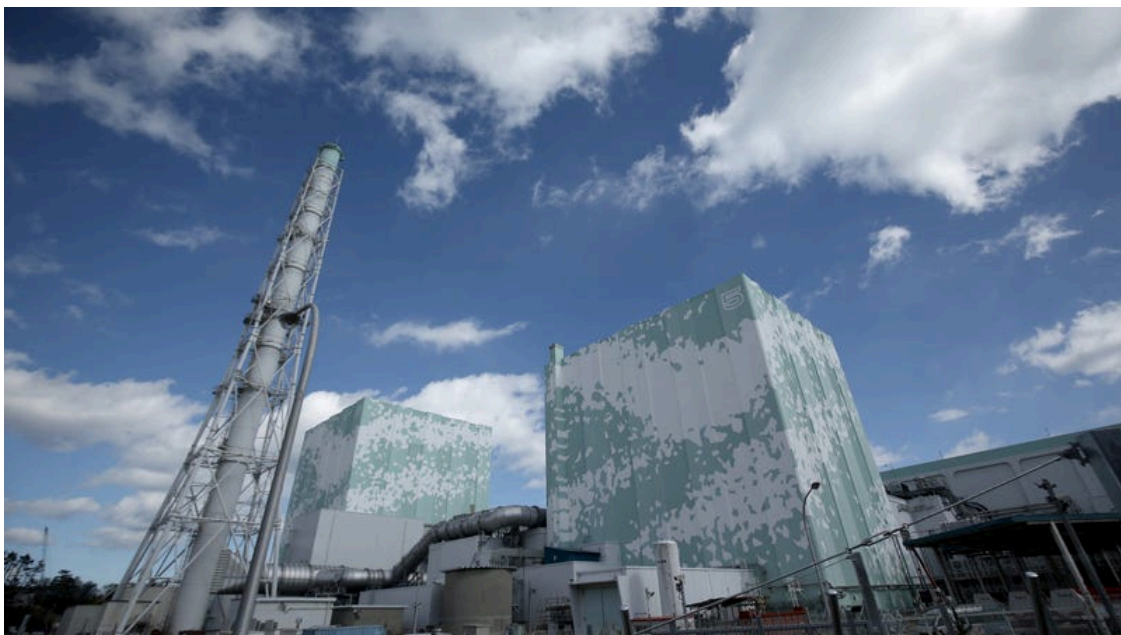
Tepco has discovered a 6.5-foot-wide hole in the metal grate under a pressure vessel in reactor No. 2's containment vessels at the Fukushima No. 1 nuclear power plant. (Image: Tepco)

In other news, a remotely-operated vehicle discovered a horrific 6.5-foot (two-meter) hole in the metal grating under the pressure vessel in the reactor's primary containment vessel. The company suspects the gash was created by nuclear fuel that melted and then pierced through the vessel after the tsunami knocked out Fukushima Daiichi's back-up cooling system.

"It may have been caused by nuclear fuel that would have melted and made a hole in the vessel, but it is only a hypothesis at this stage," explained a Tepco spokesperson to AFP. "We believe the captured images offer very useful information, but we still need to investigate given that it is very difficult to assume the actual condition inside."
